## **INSPECTION AND MAINTENANCE DESIGN OF STEEL BRIDGE**

Raghabendra Yadav

**ABSTRACT:** Bridges are the major elements of road network which should always be in good working condition. Good working conditions can be achieved by routine, periodic and emergency maintenance after the bridge construction. For this study Bokse River Bridge is selected which is located in Jalbire village development committee of Sindhupalchok district along the Balephi (Arniko Highway-Asian Highway) to Jalbire in Nepal. For the inspection and maintenance of bridge the work is divided into two major parts namely desk study and field work. The relevant data related to the bridge was collected during desk study then in the field study the detail survey was done. IRC: SP: 74-2007, Guidelines for Repair and Rehabilitation of Steel Bridges was used for the maintenance of the bridge. Based on the inspection of the structural elements of the Bokse River Bridge, the bridge is in poor condition and needs attention as soon as possible. In this paper, inspection of bridge, geological condition, maintenance design and preventive measures are discussed in detail.

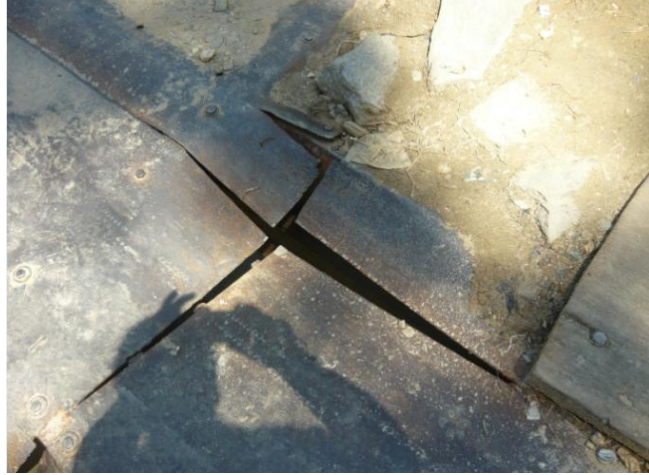
From the inspection, steel plates are deflected and not in good condition. The plates are buckled, joints are disconnected and rusted. The conditions of decking system are shown in Figure 4.

*Figure 4.* Condition of Decking System

- The repair and maintenance program are recommended as follows:
- Replace the Steel plate, cross girders, stringers, and damaged gusset plates of different size, damaged seat angles, damaged / malfunctioning nut bolts
- Chiseling and Epoxy grouting in concrete spalling portion.
- Sand blasting and painting in the bridge.

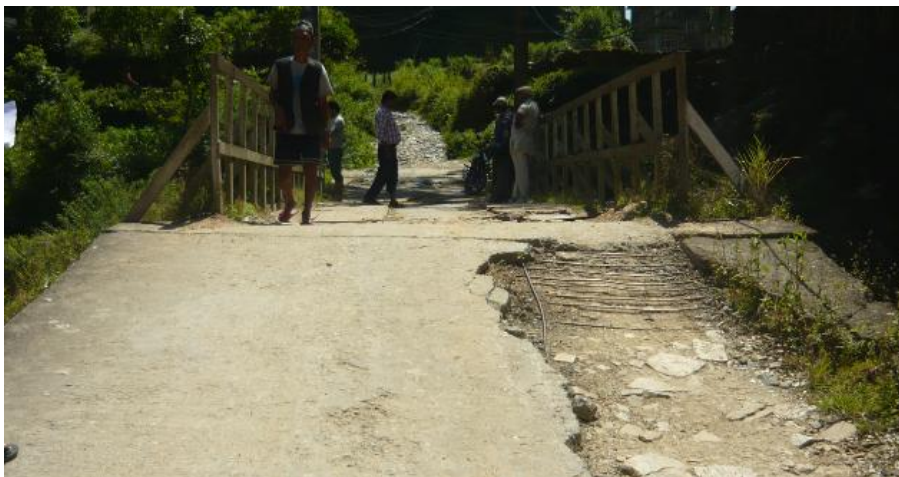
- **Cross Girders:**  
Cross girders are buckled and rusted, so all cross girders are need to be replaced.
- **Stringer Beam:**  
Stringer beams are buckled and rusted, so all stringers are needed to be replaced.
- **Railings:**  
Railings are in good conditions.
- **Approach Slab:**  
All the concrete in approach slab are spalled and rebar were exposed.

*Figure 5.* Concrete spalling in approach slab

For the approach slab, it has to be reconstructed. For the other parts of bridge, rusting should be removed by using sand ballasting methods. Vegetation should be removed.
