## **CASE STUDY: INVESTIGATING THE FAILURE OF KHANI POST-TENSIONED CONCRETE BOX GIRDER BRIDGE IN ZAKHO – IRAQI KURDISTAN**

**ABSTRACT:** Khani bridge in Zakho / Iraqi Kurdistan is under construction on Khabour River. The bridge has one simply-supported span of 63m and designed to have a non-prismatic post-tensioned concrete single-cell box girder section. This bridge, which consists of two box girders (Girder 1 for left side and Girder 2 for right side) encountered an excessive deflection during construction after removing the shores and caused a uniform deflection along the span with a maximum deflection of more than 47cm in the middle for Girder 1 bridge and 67 cm for Girder 2.

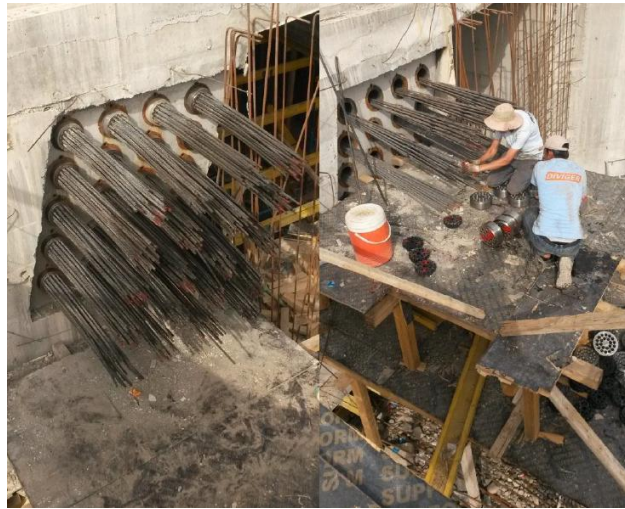
Figure 10. Tendon installations

3. The timing for tendon pulling was not appropriate. The tendons were pulled only three days after casting the top slab of the girders. The top slab did not reach its required compressive strength when the strands were pulled and applied post-tensioning stress on concrete. This means that the whole box section did not behave the same during the post-tensioning and acted more like a composite section instead of one piece box.

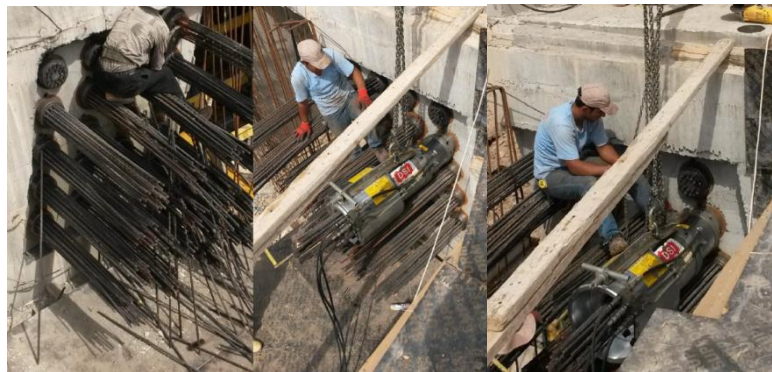
Figure 11. Tendon stressing process and grouting

Another problem is that the tendon stressing started from the top tendons and came down to the bottom ones rather than starting from the bottom first (Figure 11). The ducts were grouted between September 16 and 19. Standard specifications and common practice were not followed for the grouting procedure. The shoring forms were stripped on October 13, 2015.

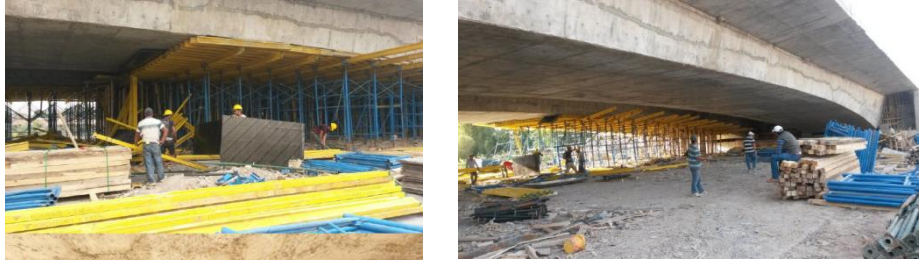
Figure 12. Shore removing and form stripping

Immediately after the shoring removed, both girders of the bridge started to deflect downwards with an average speed of more than 3cm a day in the first 10 days and then started to slow down but did not stop until Girder 1 stopped finally at 47 cm and Girder 2 stopped at 67 cm. This deflection took approximately 90 days.

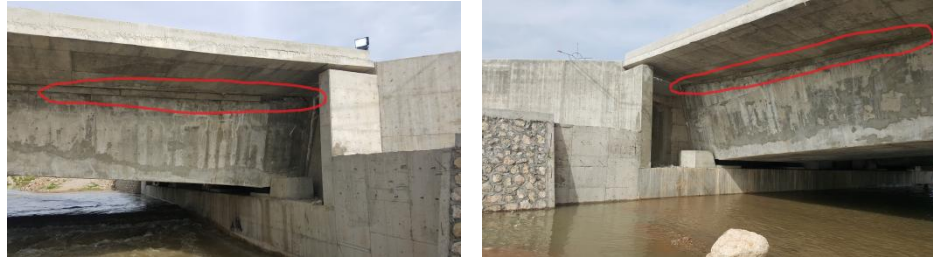
Figure 15. Cracks at interface from both ends

A third party conducted an investigation based on Duhok Governorate request and they submitted a report concluding that horizontal shear failure at the interface between the top deck slab and the walls is to be blamed for the excessive deflection. They supported their claim by some pictures taken of the cracks occurred at the interface for a good distance from both of the ends (see Figure 15 and Figure 16). This third party also concluded that the total deflection of this bridge according to the current design must not exceed 13cm.

The same report claimed that the cracks at the interface between the top deck and the walls reduced the section and as a result, leads to the excessive deflection. This claim does not have a strong ground because these cracks that mentioned in Mega report did not appear until the deflection reached 180mm according to the site engineers. In fact, the authors of this paper visited the site on the first week that the failure happened and took pictures of the same areas that showing no cracks. The construction joints shown in Figure 17 are those that submitted as part of the design drawings.

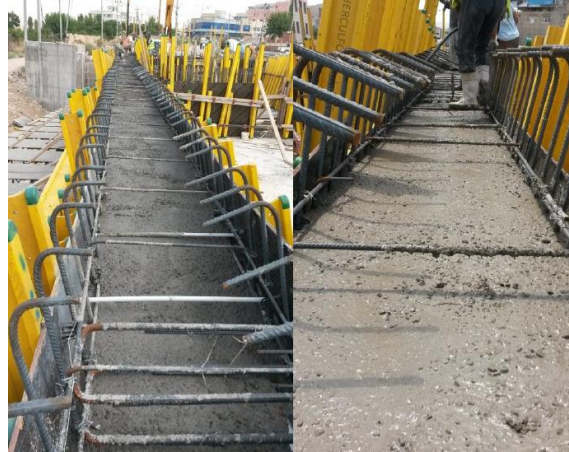
Figure 18. Top surface of the walls left as is without roughening

The horizontal shear resistance was calculated and showed that the resistance to the horizontal shear is sufficient to hold the section together as a composite section. This analysis is based on a fact that the Contractor did not follow the

design notes and drawings in roughning the top surface of the walls but rather left it as is (see Figure 18). As such, the cohesion and friction factors were lowered for unroughened surface. Despite that, this analysis showed that the interface shear resistance is sufficient to hold the section together.

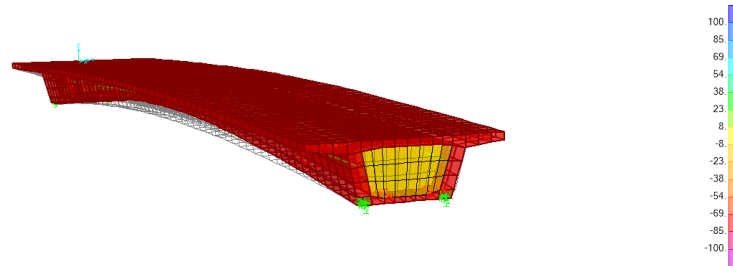
Figure 27. Deflection due to prestress load of tendon force using the data from test after the failure

In this part, the bridge girder is analyzed with inputting the data from Table 3. As analyzed above, the total tendon force of all the 20 tendons of each wall is 63,462 kN instead of 92,400 kN of the design. The ultimate stress  $F_u = 1991 \text{ MPa}$  and the yield stress  $F_y = 1729 \text{ MPa}$  are also used in accordance with the test data in Table 3. The results show that the deflection camber due to prestress is reduced to 9.56 cm.

This decrease in the camber due to prestress increases the total deflection to 18.82 cm. This large deflection causes the stresses to cross the limits specified by AASHTO by large amount.
