SEISMIC PERFORMANCE OF HOLLOW-CORE COMPOSITE BRIDGE COLUMNS

ABSTRACT: This paper presents the behavior of hollow-core fiber reinforced polymer-concrete-steel (HC-FCS) bridge columns under seismic loading. The HC-FCS column consists of an outer fiber reinforced polymer (FRP) tube, an inner steel tube, and a concrete shell between them. Seven large-scale columns were tested under combined constant axial compressive and cyclic flexural loadings until failure. The investigated columns were one reinforced concrete (RC) column, four HC-FCS columns, and two repaired HC-FCS columns. The outer diameter of each column was 610 mm (24 inches) and the height was 2,413 mm (95 inches) with span-to-depth ratio of 4.0. The steel tube of each HC-FCS column was embedded 635 mm (25 inches) into its own footing while the FRP tube stopped at the top of the footing. The FRP confinement ratio, the steel tube diameter-to-thickness ratio, and the steel tube diameter were examined during this study.

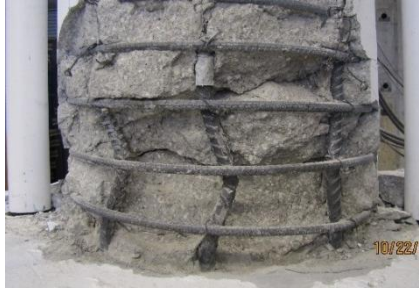
F4-24-RC: rebar fracture

Figure 8. Failure modes of the investigated columns

As shown in the Fig. 7a, the column F4-24-RC behaved linearly up to a lateral drift of 0.5% followed by yielding of the flexural rebar at drift of 1.1% and gradual stiffness degradation up to a lateral drift of 2.0%. The average moment capacity of the column was 594 kN.m (438 kip.ft) which occurred at a lateral drift of approximately 5.1%. The failure of the column occurred at the first cycle of the lateral drift of 10.9% due to fracture of one rebar at each of the north and south sides of the column. During the second cycle of the same drift, other two rebars fractured at each of the north and south sides with a total of six rebars fractured out of eight rebars (Fig. 8a). The severe damage zone of the column was within the bottommost 229 mm (9 inches) of the column. The readings of the strain gauge showed that the maximum axial tensile strain of the farthest flexural steel rebars was 18,000 $\mu\epsilon$. The farthest steel rebars buckled in compression at a lateral drift of 7.5%. By the end of the test, the column displayed a displacement ductility of 9.9.

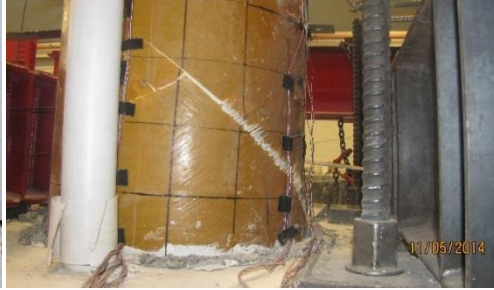
F4-24-E324: rupture of FRP tube

In the case of F4-24-E324, the moment was almost constant up to a lateral drift of approximately 6.0%. After that, the moment reduced gradually until failure occurred at a lateral drift of 15.2% when the GFRP tube ruptured at an ultimate hoop strain of 13,130 $\mu\epsilon$ (Fig. 8b).

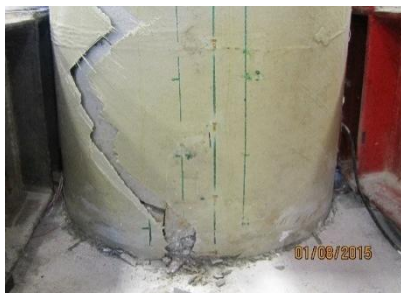
F4-24-P124: rupture of FRP tube

In the case of F4-24-P124, the column suffered stiffness softening until the failure of the column at a lateral drift of 5.8% when the GFRP tube ruptured at an ultimate hoop strain of 6,150 $\mu\epsilon$ (Fig. 8c). The strain readings showed that the maximum axial tensile strains of the steel tubes were 11,000 $\mu\epsilon$ and 14,000 $\mu\epsilon$ in the case of F4-24-E324 and of F4-24-P124, respectively. Furthermore, the steel tube locally buckled at a lateral drift of 3.0% in the case of F4-24-E324 while it did not buckle in the case of F4-24-P124 due to the low confinement ratio. The steel tube local buckling of the F4-24-E324 was the reason of the lower axial tensile strain than that of the F4-24-P124 as the steel tube could not gain more strains with cycling the column. The no buckling behavior was confirmed through axial strain measurement as well as the video cameras

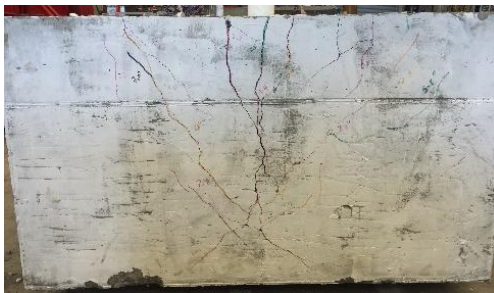
F4-24-E344: footing cone failure

The column F4-24-E344 behaved linearly up to a lateral drift of 0.5% followed by the appearance of a fine vertical crack at the midway of the footing length at a lateral drift of 1.4%. Further cycling led to yielding of the steel tube in tension at a lateral drift of 1.8% and propagation of cracks into the footing shaping the common cone-shape of the pullout failure due to the insufficient steel tube embedment length. Gradual stiffness degradation initiated at 0.5% and continued up to a lateral drift of 7.7% (Fig. 7d). The hysteretic curve of the column displayed significant pinching during the reloading cycles (Fig. 7d). The average moment capacity of the column was 1,186 kN.m (875 kip.ft) which occurred at a lateral drift of 7.7%. Severe damage of the footing occurred at a lateral drift of 8.0% and continued until the test was ended at a drift of 11.6% when the column strength dropped by 15% (Fig. 8d). The maximum hoop tensile strain of the GFRP tube was 11,800 $\mu\epsilon$. The maximum axial tensile strain of the steel tube was 15,200 $\mu\epsilon$ while no steel tube buckling was recorded. The column displayed a displacement ductility of 6.4.

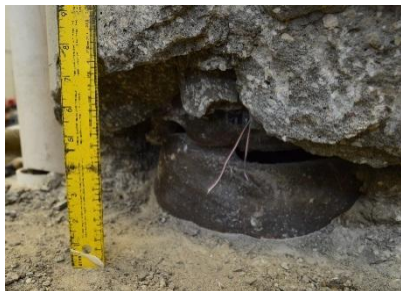
F4-24-E325: steel tube tearing

However, cycling the column continued until a lateral drift of 15.6% when the actuators reached its maximum stroke. No damage occurred to the GFRP tube by the end of the test with the maximum recoded hoop tensile strain of 10,000 $\mu\epsilon$. The maximum axial tensile strain of the steel tube was 10,600 $\mu\epsilon$ while the steel tube locally buckled at a lateral drift of 3.2%. Once the test was concluded, the steel tube was exposed and investigated by removing part of the GFRP tube. It was found that the steel tube suffered severe local buckling along with steel rupture within the bottommost 127 mm (5 inches) of the column (Fig.

8e). The column displayed a displacement ductility of 6.0.

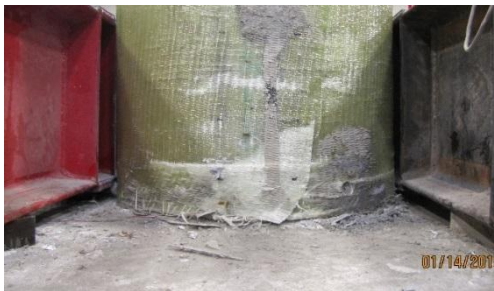
F4-24-P124-R: rupture of FRP wrapped layers

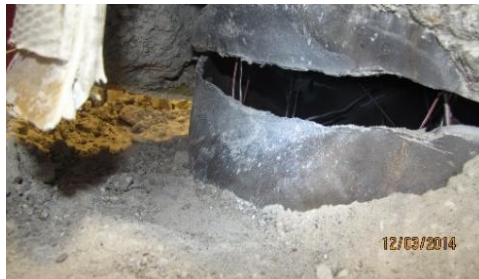
F4-24-E324-R: steel tube tearing

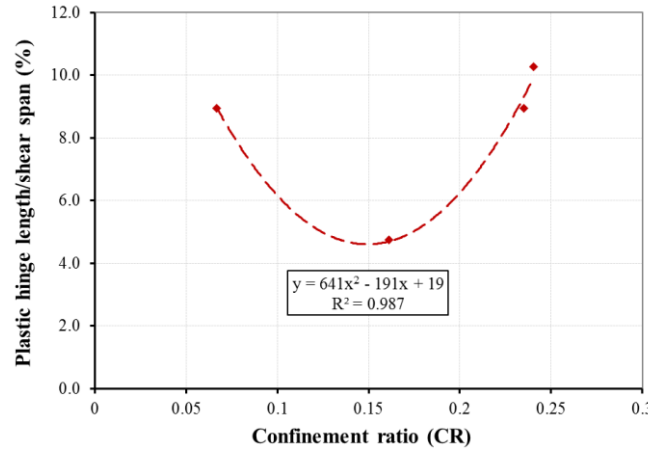
Figure 15. FRP confinement ratio versus the percentage of plastic hinge/shear span of the HC-FCS columns

The region where concentrated nonlinear deformations take place in a structural element is defined as the plastic hinge length (l_p). In the case of conventional reinforced concrete columns l_p includes two regions, i.e., the steel yield penetration depth into the footing region (l_{py}) and the region above the footing where the nonlinear deformations take place (l_a). In the case of the HC-FCS columns, the l_a was linked to the FRP tube hoop strains and defined as the region from the top of footing to where the FRP hoop strain dropped to one-third of its maximum value at the same drift cycle [37]. Using this definition, the l_a of the columns F4-24-E324, F4-24-P124, F4-24-E344, and F4-24-E325 was 10.3%, 8.9%, 4.7%, and 8.9% of the columns' shear span (H), respectively. These results agreed with the damaged lengths of these columns that was noticed in the investigation after the tests along with the curvature results measured by the LVDTs. Per the previous definition of the l_a , the FRP confinement ratio is the main parameter affecting the l_a of the HC-FCS columns. Figure 15 and Equation 12 illustrate the nonlinear relation between the confinement ratio and the l_a/H of the investigated columns. The equations were developed based on simplification of the regression analyses results. The lowest value of the l_a/H was 4.6% which happened at a confinement ratio of 0.15.

$$L_a/H = 641 CR^2 - 191 CR + 19 \quad (12)$$
