EXPERIMENTAL EVALUATION OF SHEAR BEHAVIOR IN FRP STRENGTHENED CONCRETE BRIDGE GIRDER

Rakesh B. Jayanna¹, Nur Yazdani²

ABSTRACT: External Fiber Reinforced Polymer (FRP) wrapping is an increasingly popular technique for the rehabilitation/strengthening and confinement of damaged concrete bridge girders. There is a general lack of knowledge on the full-scale experimental evaluation of FRP wrapped girders. This is especially true for the shear behavior of concrete girders with vertical FRP application. In this study, a full-scale standard Texas bridge I-girder with typical prestressed and non-prestressed steel was experimentally evaluated for three-point shear load capacity, and concrete cracking. A common unidirectional carbon FRP (CFRP) in the form of U-wraps was utilized. Load was applied near one support to induce maximum shear force in the girder. The U-wrapped FRP increased the shear capacity of the girder by about 11%. Typical flexural-shear cracking was observed. The crack initiation and propagation was delayed by the presence of CFRP layers. The girder behaved in an elastic manner during the shear loading phase. Difficulty with FRP U-wrap application in the field may decreas

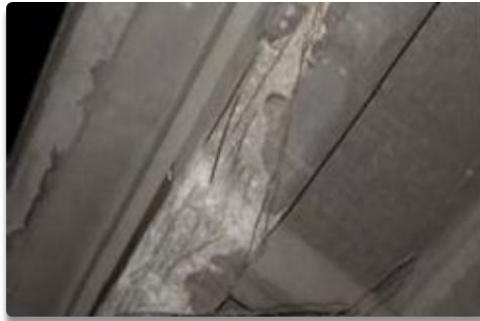
(a). Damaged

(b). Repaired

Figure 1. Damaged and repaired prestressed concrete girder

A total of 24 highway departments are currently using FRP laminate application as a bridge retrofitting technique. The Texas Department of Transportation (TxDOT) is currently maintaining over 30,000 bridges, most of which include precast prestressed concrete girders and cast in place concrete piers. Each year, a number of these girders are damaged due to vehicle impact, rebar corrosion and structural deterioration. Over height vehicles collision due to low clearance of older bridges or increase of roadway overlay thickness is the primary cause of the first type of damage [4]. The damage may be minor, or could be severe that includes spalling of concrete and damage or breakage of prestressing strands, as seen in Figure 1a. Therefore, for severe cases, the damaged girders are repaired and strengthened as soon as possible to maintain the safety and load carrying capacity of the girders. Among other repair methods, TxDOT has been using external strengthening of damaged concrete bridge girders with fiber reinforced polymer (FRP) fabrics since 1999. More than 30 such bridge strengthening has been performed in the state to date. The FRP strengthening is typically applied after any damaged prestressing strands are spliced and re-tensioned, and the spalled concrete replaced with new repair concrete (Figure 1b). Besides providing additional strength, the FRP strengthening adds confinement to the concrete, prevent significant spalling of concrete in case of future damage at the same location, and increase the durability.

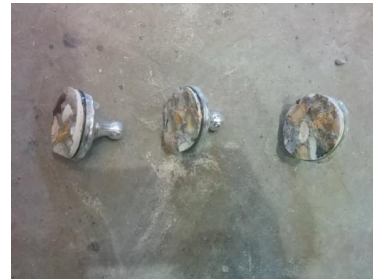
(a). Tester application

(b). Failed samples showing good bond

Figure 5. Pull-off testing

The strengthening of concrete structures by using FRP system depends mainly on the interface bond between the FRP sheets and concrete surface. The bond quality is affected by any lack of proper surface preparation, epoxy mixing, epoxy application and the FRP application onto the concrete surface. Inadequate bonding results in inadequate stress transfer and resulting insufficient composite action. One popular method to spot check the bond quality is the ASTM Pull-Off Testing [17]. In this test, a 50 mm circular dolly is glued to the CFRP surface. After 24 hours of curing, the dolly is pulled off from the surface with a tension tester (Figure 5a). If the failure surface is within the concrete substrate, a good bond quality is indicated. A failure in the CFRP or epoxy indicates inadequate bond quality. In the current study, three random pull off tests were performed on the CFRP. All samples showed adequate ASTM acceptability with failure in the concrete substrate, indicating good workmanship and bond quality (Figure 5b).

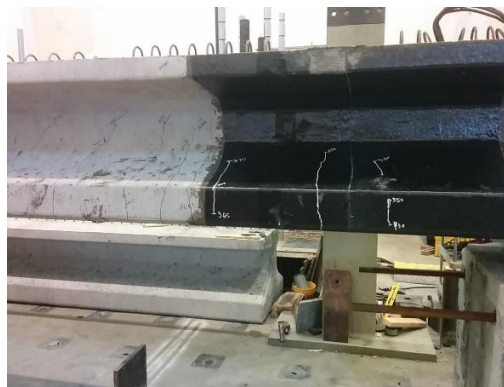
Figure 7 shows photographs of crack patterns in the girder at the maximum applied load. Cracks first appeared in the CFRP at 454 kN load. With increased loading beyond first cracking, the number of cracks and the crack widths increased. Some cracks changed from vertical flexural type to inclined flexure-shear type at some distance from mid-span. It was difficult to locate cracks under the CFRP layers near the load application area at the support. Most cracks demonstrated a flexure-shear type behavior.

*Figure 7. Cracking in girder*

- c) Shear cracking in FRP strengthened girders initiate as flexural cracks and subsequently change into diagonal tension cracks, as expected. It is difficult to locate concrete cracks that are covered by the FRP laminate during the experiment.
