## **EFFECT OF OVERHANG DECK CONSTRUCTION ON PLATE GIRDER BRIDGES**

**KEYWORDS:** Plate girder bridge; Exterior girder rotation; Screed machine; overhang deck; Tie bars; Construction loads.

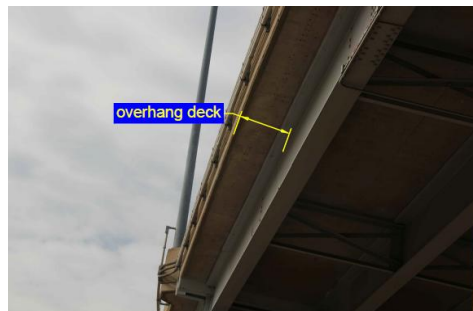
Figure 1. Overhang deck in a typical steel girder bridge

Bridge decks typically overhang past exterior bridge girders. In fact, the extended portion of the deck (shown in Figure 1) is normally balanced so the same girder section can be used for both the interior and exterior girders. During deck construction, loads on the overhang (load from screed machine, fresh concrete, construction personnel, etc., as shown in Figure 2a) are supported by wood sheathing supported by steel brackets placed every 3 ft. to 6 ft. along the length of the exterior girders (as shown in Figure 2b).

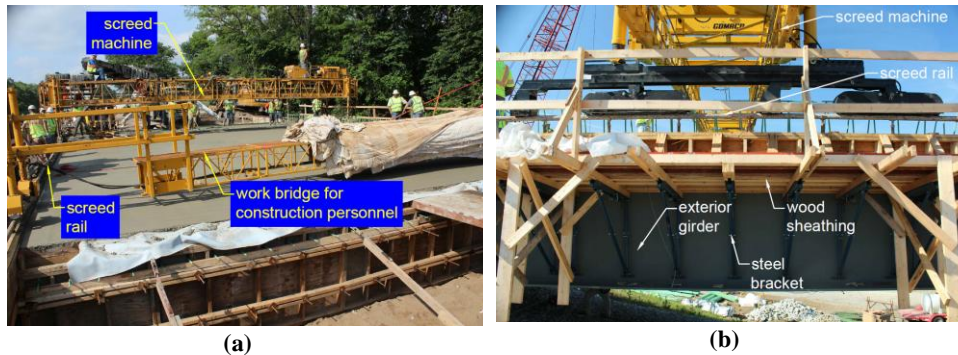
Figure 2. Concrete pouring and finishing work using screed machine

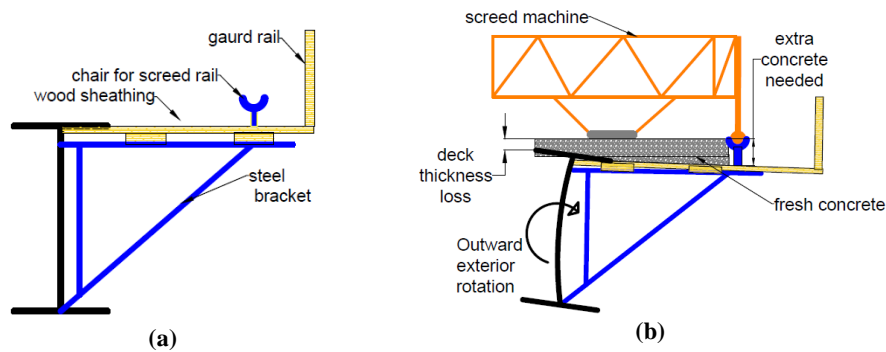
Figure 3. Exterior girder rotation due to unbalanced eccentric load on overhang deck

The eccentric unbalanced loading from the overhang deck can introduce exterior girder rotation during concrete placement when the concrete is still plastic, as shown in Figure 3. Rotation in plate girder bridges usually depends on the number of spans, span length, depth of the girder, and the distance between lateral bracing and their connection with the girder [5,6]. Other factors that influence exterior girder rotation include the overhang deck width, total construction loads (plastic concrete, screed machine, construction personnel, work bridge for construction personnel, etc.), and most importantly, the effectiveness of the bracing system (tie bars that connect exterior to exterior girders and timber blocks to exterior girder rotation) used to prevent exterior

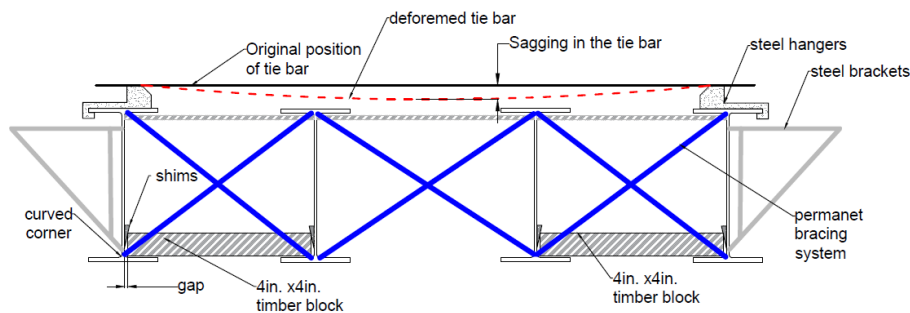
Figure 4. Temporary bracing system to prevent exterior girder rotation

A commonly used bracing system in the state of Illinois includes transverse tie bars and wooden struts. The transverse tie arrangement (shown in Figure 4) includes a No. 4 steel reinforcing bar connected from one exterior girder to the opposite exterior girder. These rotation prevention tie bars are typically placed at a 3 ft. to 4 ft. spacing along the length of the bridge. Effectiveness in tightening the ties plays a significant role in their effectiveness. Square timber blocks (4 in.  $\times$  4 in.) are used as struts in between the exterior and first interior girder to prevent rotation as shown in Figure 4.

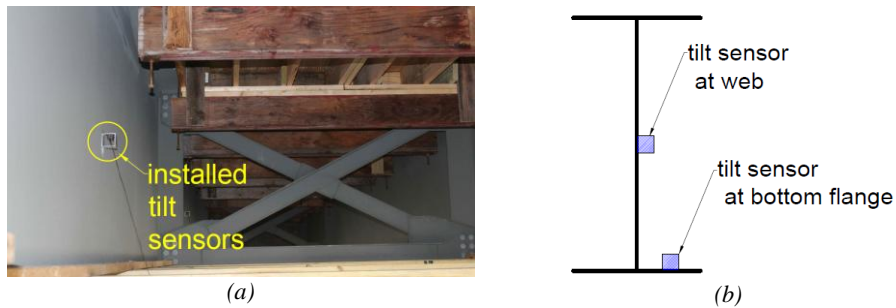
Figure 5. Installed tilt sensor in the bridge: (a) tilt sensor, (b) locations of tilt sensors

Dual-axis (transverse and longitudinal direction) tilt sensors were used to monitor girder rotations. Tilt sensor locations are shown in Figure 5. The tilt sensors are capable of measuring  $\pm 20^\circ$  rotation. Extra care was taken during installation to ensure the tilt sensors were installed perpendicular to the girder web and flange. All rotations were measured in degrees.

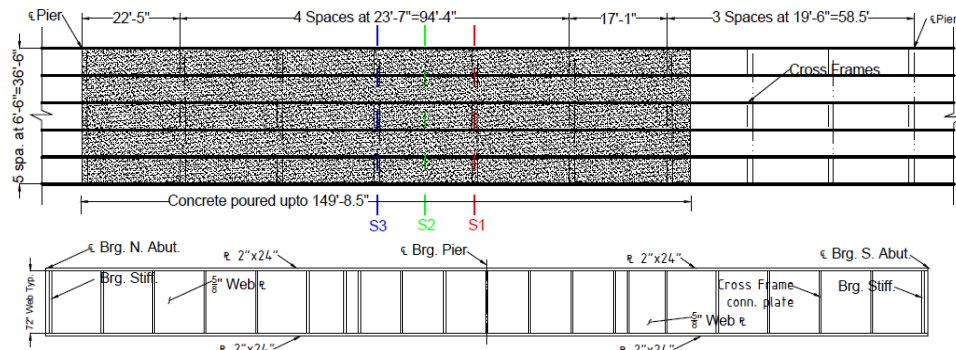
Figure 6. Bridge A. plan of the bridge (top), and elevation of the exterior girders (bottom)

The sections used for instrumentation are shown in Figure 6 and Figure 7 for the non-skewed and skewed bridge, respectively.

The most important point during construction is related to placement of the plastic concrete, and in this study, the plastic concrete was not placed over the full span for both bridges. For bridges A and B, the concrete was placed up to 149’-8.5” (from existing deck) and 78’-0” (from abutment), respectively. The concrete placement locations are shown in Figures 6 and 7.

Exterior girder rotations monitored from the field are presented, as shown in Figures 9 through 11 for three sections. In the case of bridge A, rotations were measured at three different sections (S1, S2, and S3), as shown in Figure 6. Section S1 experienced the largest “maximum rotation” in the exterior girder (around  $0.09^\circ$  for both web and flange locations) for both bridges. The maximum rotations (in both the web and flange, as shown in Figure 5b) were very close to the rotation measured at section S1. Residual rotations were negligible (around  $0.03^\circ$ ) for all sections, as shown in Figures 9 to 11.

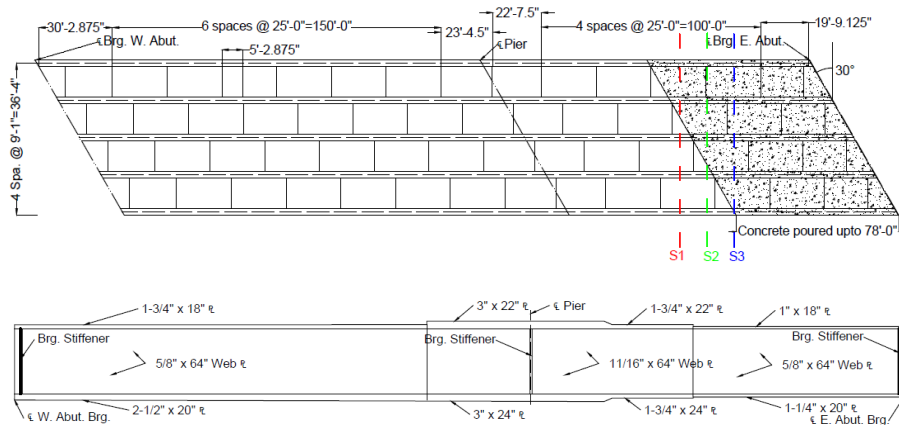
Figure 7. Bridge B. plan of the bridge (top), and elevation of the exterior girders (bottom)

For bridge B (skewed bridge), the values of “maximum rotation” (as shown in Figure 9 to Figure 11) are slightly higher than the maximum rotation monitored in bridge A. Looking at all the sections (shown in Figure 7) in bridge B, it can be seen that the largest “maximum rotation” was  $0.17^\circ$  which occurred at section S2 (at a crossframe location) which is slightly larger than sections S1 and S3. The reason for that might take place due to the vibration effect on the sensors induced during construction. The rotation values where crossframes exist are not expected to be higher than the other location without any crossframes. The residual rotations (approx.  $0.05^\circ$ ) for all sections of bridge B are small compared to the rotation limit, as shown in Figures 9 through 11.

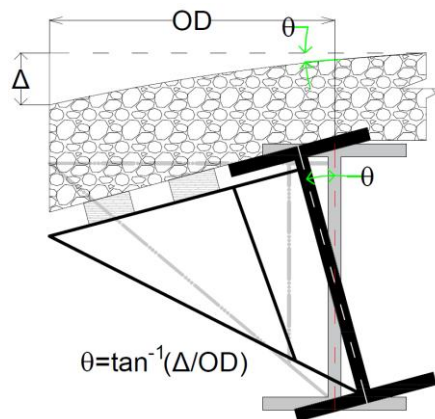
Figure 8. Determining “rotation limit ( $\theta$ )” for exterior girders during overhang deck construction

The “rotation limit ( $\theta$ )” is the rotation corresponding to the maximum allowable

deflection ( $\Delta$ ) at the overhang tip (maximum  $\Delta=3/16$ in. as per IDOT bridge design manual [7]) for the overhang as shown in Figure 8. The “rotation limit” for bridge A and B are  $0.27^\circ$  and  $0.26^\circ$ , respectively.

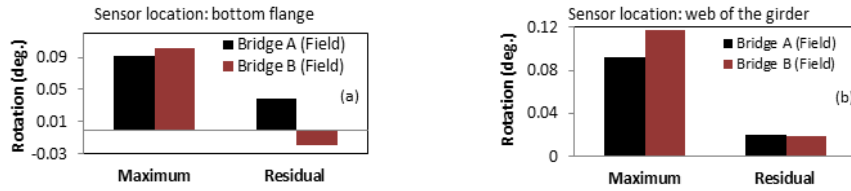
Note: Rotation limit= 0.27° for bridge A and 0.26° for bridge B

Figure 9. Exterior girder rotation at section S1

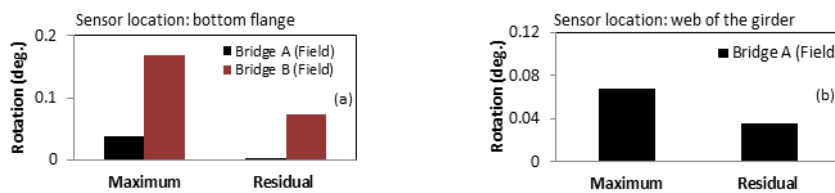
Note: Rotation limit= 0.27° for bridge A and 0.26° for bridge B

Figure 10. Exterior girder rotation at section S2

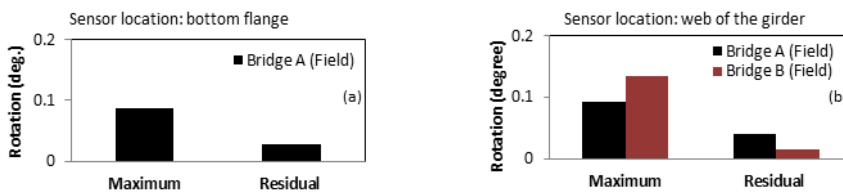
Note: Rotation limit= 0.27° for bridge A and 0.26° for bridge B

Figure 11. Exterior girder rotation at section S3

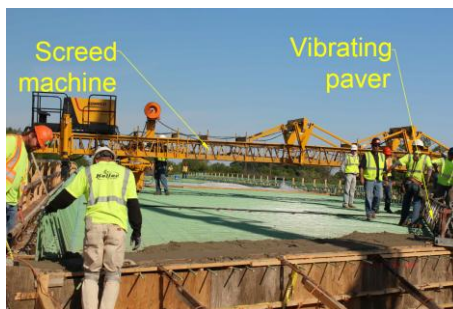
Figure 12. Vibrating paving machine and screed the machine during construction

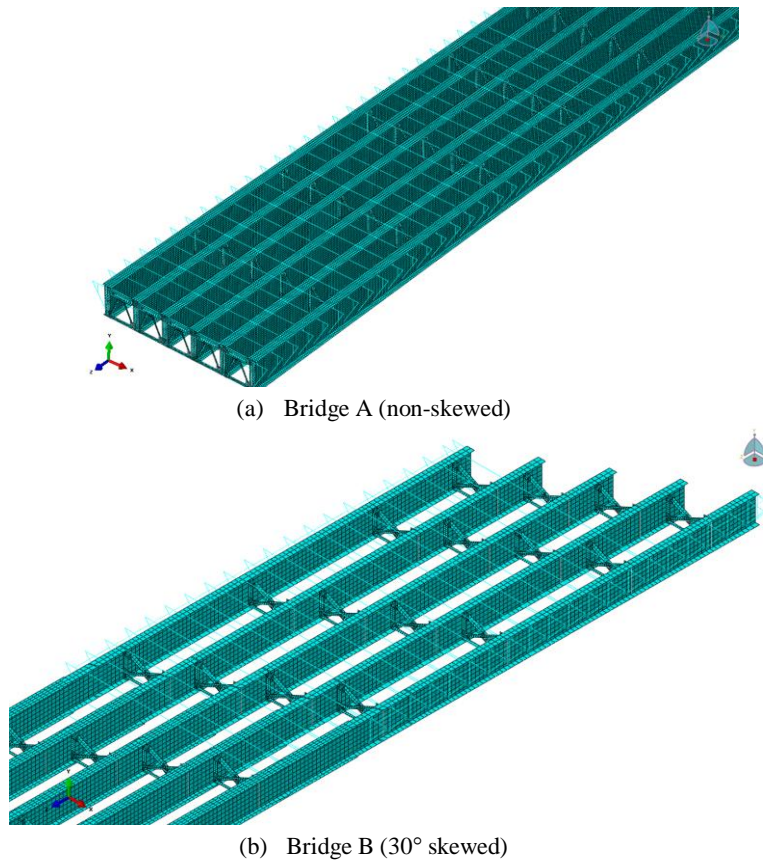
Figure 13. Finite element model for bridge A and B

Full-scale FE models of bridges A and B are shown in Figure 13 and are based on actual plan dimensions. Bridge girders and diaphragms were modeled using shell elements, and transverse tie bars were modeled using linear truss elements. Overhang steel brackets were modeled as beam elements. Transverse tie bars are usually affected by sagging during construction and installation, as shown in Figure 4, due to self-weight, interference with other reinforcement, and improper tightening. This can lead to ineffectiveness of the ties and result in more rotation. In the finite element study, a nonlinear link element (translator) was used with an assigned "gap" (0.5 in. for bridge A and 0.1 in. for bridge B) to simulate sagging (as shown in Figure 4) of the transverse bracing bars in the field. The 4 in.  $\times$  4 in. timber blocks were assumed to be improperly shimmed due to the fillet at the corner of the web and bottom flange, as shown in Figure 4. A truss element was used to represent the timber blocks, and in the connected nodes, a nonlinear translator link with an assigned gap (0.22 in. for bridge A and 0.1 in. for bridge B) was used as a constraint between the timber blocks and girders to simulate the gap. In both cases (tie bars and timber blocks), the gap value in the nonlinear translator connector was determined through trial and error by matching field-measured rotations to calculated rotations.

Fresh concrete loads from an 8-in. deck were divided based on the tributary area of the girder and then distributed over the surface area of the top flange of the girders. The concrete deck overhang load was placed directly on the steel bracket. Different types of screed and finishing machines (vibrating bridge paver, Bidwell M-3600, GOMACO C450, etc.) were used during construction. The weight of the screed machine depends on the type and function as well as the width of the deck. The application of loading was done for each section individually. For example, in the case of section S1, the loads (concrete loads on girders, screed load, and overhang load) were applied from the bridge abutment up to S1 in order to get the maximum rotation of that section. On the other hand, the plastic concrete load was applied over the entire deck to achieve the residual rotation. Boundary conditions were assigned to simulate the continuous bridge.

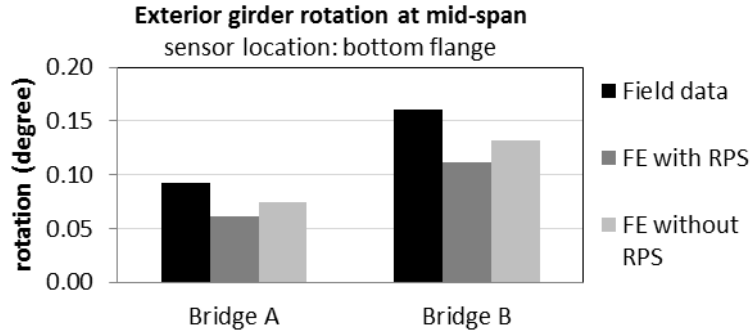
Note: Rotation Limit=  $0.27^\circ$  for bridge A and  $0.26^\circ$  for bridge B, RPS= rotation prevention system

Figure 17. Effect of bracing system in preventing rotation

To check the maximum expected rotation in the exterior girders of bridges A and B, the finite element models of the bridges were modeled without a rotation prevention system (*e.g.*, tie bars and timber blocks). In Figure 17, the influence of rotation prevention systems is illustrated and a comparative study with and without rotation prevention systems is shown for both bridges. It can be observed from the FEA that the exterior girder rotation of the FE model without a rotation prevention system is only slightly higher than the rotation obtained for models with tie bars and timber blocks.

It can be seen from Figures 14 through Figure 17 that none of the rotations in both bridges exceed the rotation limit, as shown in Table 1. Moreover, it was observed that the maximum rotations in both bridges, even without a rotation prevention system, were smaller than the rotation limit. Therefore, it can be deduced that the plate girder bridges are adequately strong in preventing rotation caused by unbalanced overhang deck loads.
