## **A CASE STUDY ON ONE OF THE SKEWED REINFORCED CEMENT CONCRETE BRIDGES IN INDIA**

**ABSTRACT:** This paper pertains to the case study on a skewed Reinforced Cement Concrete deck Slab Bridge constructed at km 5.300 on Gotogali Goyar major district road in Karwar Taluka of Uttar Kannada District in India. The work pertains to the Karnataka Public Works, Ports and Inland Water Department. The author was working as an Assistant Engineer in the same department in design section. The author designed this bridge and had issued the design details along with working design drawings to the field engineers for execution. The location of the bridge is in a thick forest area under wildlife protection zone. In the design of a bridge, it is always preferred to fix the alignment of the bridge in such a way that it should make a right angle to the river flow which helps in easy flow of water and gives clear vision for traffic movement. But sometimes due to restrictions at site and other local obstructions, it may not be possible to fix the alignment of the bridge at right angles to the flow of the river. In such cases, the bridge has to be designed as a skewed bridge. The inclination of the cen

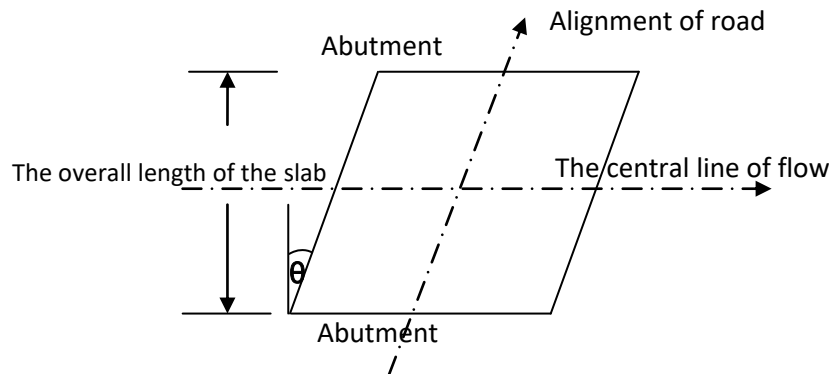
Figure 1. Skew angle  $\theta$  is shown

8. Span length, deck area, length of Abutments and piers will economic..	Span length, deck area, length of Abutments and piers will increase in proportion to cosec ( $\theta$ ) where $\theta$ is the skew angle.

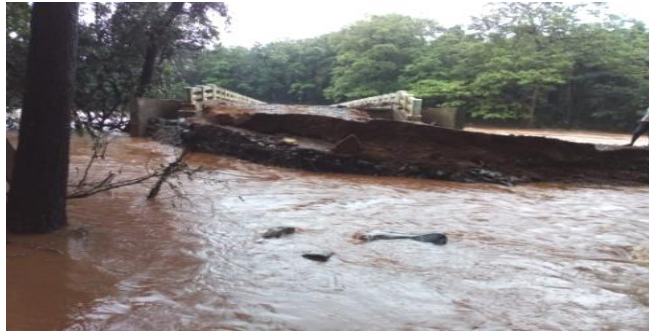
The bridge was subjected to many forces in addition to hydrodynamic forces. There were many impacts on substructures due to the flow of debris. Big trees of length varying from 2.0m to 8.0m and girth of 1.0m to 1.20m were dragged by the flow of water in the stream and chocked the vents of the bridge. About 3 spans out of 7 were almost chocked. Thus the water was being catered about 42 to 43%, Photo [4]. Remaining discharge and due to eddy current, the water was diverted towards the right side on U/s bund. Some quantity of discharge was overflowed above the deck to a depth of 1.0m, Photo [3]. Due to the diversion of water towards the right bank of U/s bunt i.e. at the entry of the

bridge the approach was completely washed away, Photo [1].

*Photo 1.* The approach is washed out

Since due to eddies and chocking of bridge vents the entrance approach was washed out, it was felt necessary to provide additional relief vents in the entrance approach portion. Length of approach was 60.0m and the depth of the water during the flood in this portion was 1.0m cross-sectional area was calculated as  $60 \times 1.0 = 60\text{m}^2$  Using equation (9) additional discharge to be catered is  $Q_{ad} = \text{area} \times \text{velocity}$   $Q_{ad} = 60.00 \times 4.55 = 273 \text{ m}^3/\text{sec}$  allowing 50% through relief vents after clearing all the vents of the bridge the discharge to be catered is  $136.50\text{m}^3/\text{sec}$ . So adopting 1.20m diameter Np2 R.C.C Hume pipes, the discharge through one row = Cross-sectional area of one pipe  $\times$  velocity. Area of one pipe =  $3.142 \times 1.2 \times 1.2 = 4.524\text{m}^2$  Discharge through one pipe =  $4.524 \times 4.55 = 20.586\text{m}^3/\text{sec}$ . So, no of pipes required to cater  $136.50 \text{ m}^3/\text{sec}$  No of rows = Discharge to be catered / discharge through one row of pipe. o of rows =  $136.50/20.586 = 6.63$  Say 7 rows

So it was suggested to provide 7 rows of 1.20m dia Np2 Hume pipes with M20 P.C.C headwall with the foundation depth equal to the foundation of returns. It was also suggested to provide arresters on the U/s of relief vents to arrest the entry of debris into the pipes. It is also suggested to construct one more span at the entrance approach for easy flow of water under floods in future. It is also suggested to provide arresters on the U/s of the main bridge to avoid the entry of the debris into the vents.

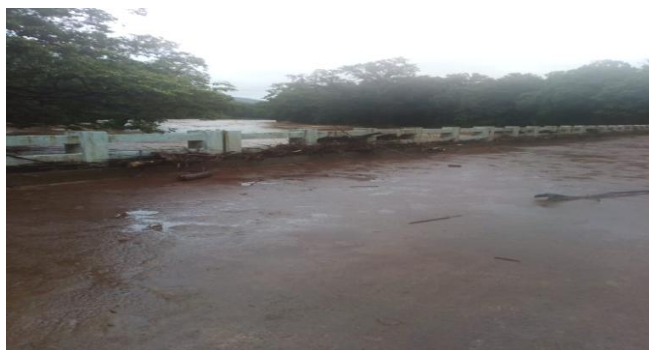
It was informed by the field engineers to the designer that the bridge is being affected by the flood and suggested to inspect the bridge. During the inspection, it was noticed that monsoon all over Karnataka and Goa (India) was the worst hit during that year (2018). It was unfortunate to note that, the early monsoon had started before taking up protection works of the embankment with Gabion retaining walls. Flood level recorded was about 1.0m more than ever before during the last 5 decades.

*Photo 3.* Water flowing above the deck. Even the openings of the R.C.C handrails are choked up with debris

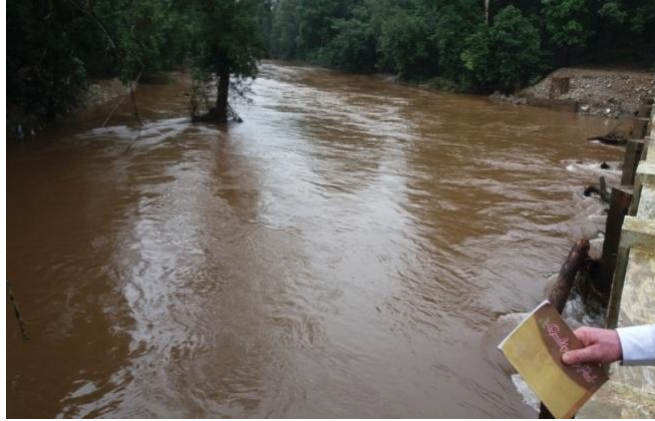
*Photo 4.* Vents choked up due to floating debris (trees) on U/s of the bridge

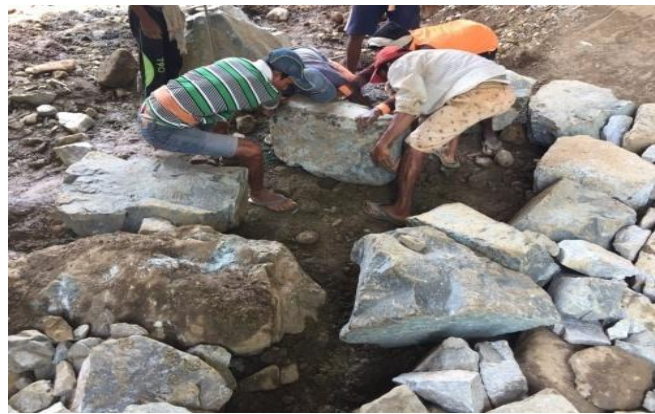
*Photo 5.* Construction of U.C.R apron

In between piers and piers and abutments for all the 7 spans, it is necessary to construct permeable apron using un-coursed rubble stone masonry with proper vertical keystones to protect the bed from scouring.
