# THE INVESTIGATION OF THE DAMAGES OF BRIDGES SUBJECTED TO THE 2020 FLOOD IN POLDOKHTAR (IRAN)

**ABSTRACT:** The investigation of the performance of bridges against various natural calamities has always been studied by researchers. Flood is one of the most important natural disasters and its effects on the performance of bridges are always considered. In this paper, the performance and damages of bridges subjected to the 2020 flood were evaluated in Poldokhtar. The studied bridges are including several steel truss bridges, a historic bridge and a bridge with a RC deck and masonry columns. Field studies have been used to investigate the effects of floods on bridges. The result of studied showed that the lack of proper connection of the deck to the abutments and cap beams has been the main reason for the destruction of the truss bridges against floods and the studied truss bridges do not perform well against floods, also it is clear that the masonry columns have a very good performance against the strongest floods due to its circular shape, considerable diameter, integrated structure and the use of breakwaters around them. Besides woods, trees, power transmission towers, etc., which

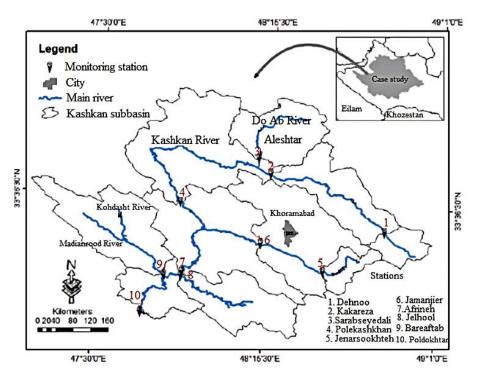
Figure 1. The map of Kashkan River [13]

Kashkan River basin is located in southwestern Iran with an area of 9276.66 square kilometers. This basin is an important part for providing water of the Karkheh River. After a distance of about 300 km, this river joins to the Seymareh River in the southwest of Poldokhtar in an area called Kalsefid, which make up the Karkheh River. *Fig.1* shows a complete view of the Kashkan River.

There are several hydrometric stations on the Kashkan River. The last hydrometric station of Kashkan River named Poldakhtar was established in 1955, which is shown in *Fig.1*.

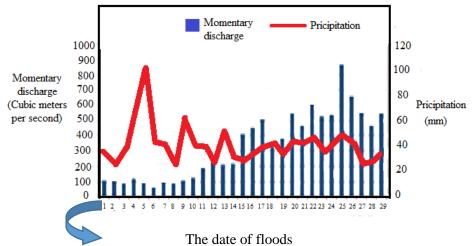
Figure 3. The comparison of the rate of the precipitation and momentary peak discharge for historical floods in Poldokhtar basin in the period of 1980-2010 [15]

According to *Fig.3* in the Kashkan River Basin from 1999 to 2010, the trend of floods has been increased and the trend of precipitations has been decreased. The momentary peak discharge rate of this basin have increased approximately four to five times from 1999 onwards compared to the previous years.

This fact shows that in recent years, the increase rate of the occurrence of floods is not only dependents on the factor of the rainfall and other factors have a significant impact on it, for example, the change use of the lands, the deforestation, urban development and rural housing development. For example, the amount of the rainfall in the 1980s was higher than it in the 1990s and 2000s, but the volume of the flood flows in the 1980s was much less than it in the 1990s and 2000s.

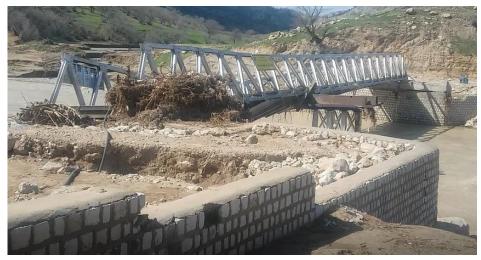
Photo 1. A view of the truss bridge between Doab-Cham Bagh villages after the 2020 flood

Due to the flood of 2019, this bridge completely destroyed and its deck fell from its supports. Despite the unsuitable performance of the bridge, a new truss bridge was built with the same structural system and in the same place and on the same substructures. Unfortunately, the new truss bridge was severely damaged by the floods of February 2020. *Photo 1* shows a view of the truss bridge after the flood of February 2020.

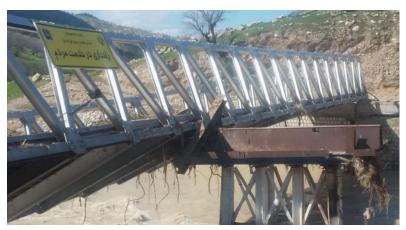
Photo 2. A view of the deck on the verge of falling after the flood

One of the most important reasons for the destruction of truss bridges against floods is the improper connection of the deck to the cap beams and abutments of the bridge. In  $Photos\ 2$  to 8, the improper connection of the deck to the cap beams and abutments of the bridge is quite obvious. According to  $Photos\ 2$  and 3 and Fig.6, the complete failure of the deck connection to the cap beams has led to a significant horizontal deflection in the deck which the deck is on the verge of falling from the cap beams and abutments. As shown in  $Photo\ 4$ , this improper performance eventually leads to plastic deformation (complex distortions) in the upper beams.

- To build a truss bridge on rivers with high risk of floods, it is recommend that the deck is not in contact with floods and the height of its columns be very long. Also, the use of a very strong connection system to connect the deck to the cap beams and abutments is very crucial.

- -The amount of length of the parts of the deck that are on the cap beams and abutments is very important, also the strength of the elements that restrict the transverse movements of the deck on the cap beams and abutments is very vital. In case of failure of the connection system between the deck with the cap beams and abutments, it is possible to prevent the deck from falling with their help.

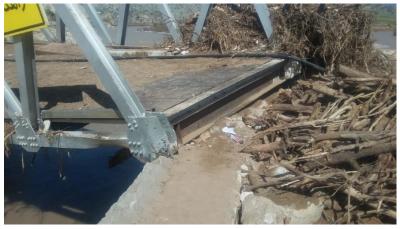
*Photo 5.* The left support of the deck fell into the river (without proper connection) and the right support lifted significantly

Due to the flood, the deck has been transversely displaced so that according to *Fig.*7 and *Photo 5*, support A fell from the abutment and support B lifted from the abutment significantly.

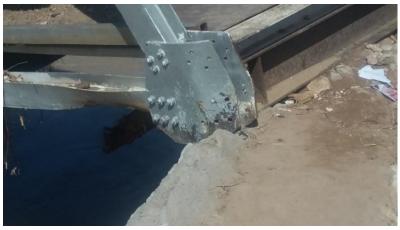
Photo 6. The improper connection of the deck to the cap beams and abutments

*Photo* 6 shows the improper connection of the deck to the cap beams and abutments. Photo 7 shows a view of the rotation of the lower beam of the deck on the abutment and *Photo* 8 shows the getting up of support B in the bridge.

- The connection of the deck to the abutments and cap beams must be designed against the phenomenon of the fatigue, because the pressure caused by the flood may for hours applied different loads on various joints of bridges.

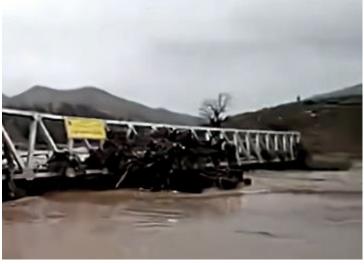
$Photo\ 9.$  The timber accumulation in front of the deck that can apply extra pressure to the bridge by blocking the water flow path

Other factors that have always led to increased pressure on bridges due to floods are the accumulation of wood in front of the deck and also fatal blows of objects floating in water on bridges. The wood of the trees collected in front of the bridge and prevented from the flow of water, and the water collected in front of the deck and puts extra pressure on the bridge. *Photo 9* shows a view of the wood collected in front of the bridge deck.

If in other cases, a bridge is equipped with the seismic bearings, depending on the type of the seismic bearings, the timber accumulation can lead to inefficiency and major damage to the equipment.

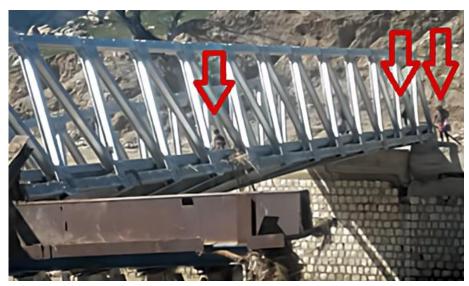
Photo 10. The dangerous passage of local residents over the damaged bridge

In terms of crisis management, rapid assessment of the bridges after floods is very important. Bridges that are unable to provide service should be blocked immediately with warning signs so that their use do not lead to increased damages. It is also important to consider alternative routes for damaged bridges. *Photo 10* shows the passage of villagers through the damaged bridge, which is very dangerous and can lead to irreparable damages.

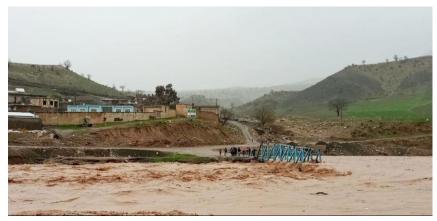
Photo 11. Truss bridge of Hayat al-Ghayb village before the destruction due to the 2020 flood

Due to the flood of 2019, the deck of the truss bridge in the village of Hayat al-Ghayb fell. Without considering any special arrangements or even a detailed inspection and evaluation of the deck, with the repairing the abutment, the deck was placed on it again. As a result, the bridge was completely destroyed due to the 2020 flood, which had far fewer discharges than the floods in 2019. *Photos 11* to 15 showed different views of truss bridge of Hayat al-Ghayb village during the 2020 flood and after its occurrence. *Photo 11* shows truss bridge of Hayat al-Ghayb village before the destruction due to the 2020 flood. According

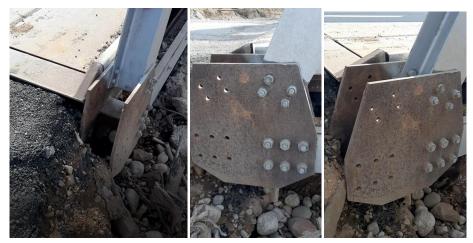
Photo 20. The different views of point A

According to *Photo 19*, if the bridge is divided into two different spans, the span BC with two the seismic bearings (Lead rubber bearing) is connected on the abutments, but according to *Photos 20* to 22, the span AB from the starting point of the bridge (point A) to the support B does not have any support connection system and the bridge is placed on the slab without any connection.

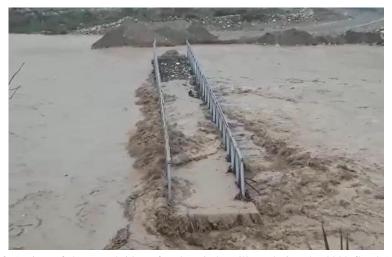
*Photo 26.* A view of the truss bridge of Kalat Zivdar village during the 2020 flood (Photo by Morteza Ghasemi-Nia)

The truss bridge shown in *Photo 26* was constructed a year ago. Prior to the recent floods, the Road Maintenance and Transportation Organization facilitated water passage by digging two channels on roads on both sides of the bridge but this led to the complete collapse of the roads on both sides of the bridge, as shown in *Photos 27* and 28.

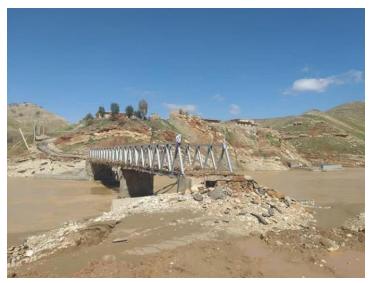
Photo 27. The destroyed road on both sides of the bridge

However, digging the channels has led to the collapse of the road on both sides of the bridge, but the bridge was not significantly damaged by the floods. Immediately after the flood, the road reconstruction operation started, the process of which is shown in *Photos* 29 to 31.

- The channel excavated around the truss bridges in this study due to very close distance between these channels to the abutments can be one of the main causes of damage to some truss bridges. Proximity of the channel to abutments may lead to scour, instability, rotation, and reduce resistance of abutments against the flood.

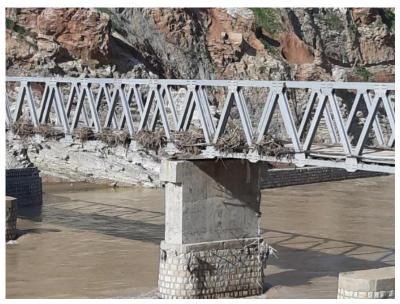
Photo 32. A view of the gathering of wood on the deck

*Photo 32* shows how wood and other materials in the water could collect before the bridge which ultimately leads to extra pressure on the bridge.

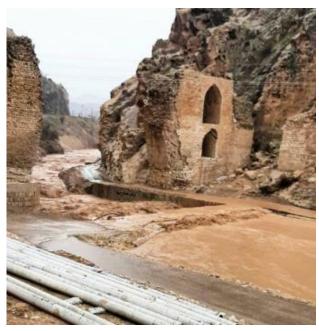
Photo 33. A view of the historic bridge and the RC bridge during the flood 2020

The Kalhor historic bridge and the Kalhor RC bridge are located close to each other. *Photo 33* shows views of these bridges when they were affected by the 2020 flood. Kalhor historical bridge was very resistant to flood due to its thick columns and the presence of breakwaters around its columns and no significant damage was caused to the bridge by the flood. *Photos 34* and *35* show views of the Kalhor historic bridge after the 2020 flood.

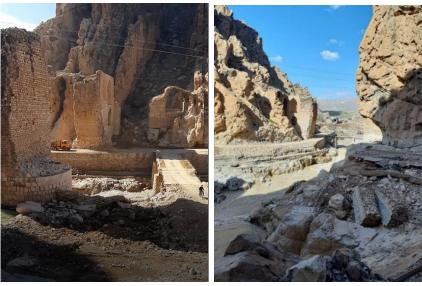
Photo 34. Views of the historic bridge and the RC bridge after the 2020 flood

Despite the fact that the Kalhor RC bridge was completely submerged due to the 2020 flood and also due to its location was under the influence of water flow with the highest speed and intensity, which showed a very good performance.

Actually, except for the limited damages on the road on both sides of the bridge, which could be reconstructed quickly, it did not suffer significant damage, which could be due to the proper design of the bridge (especially the proper connection of the deck to the cap beams and abutments).
