STRENGTHENING AND MAINTENANCE MEASURES OF A BAILEY-TYPE ROAD BRIDGE

ABSTRACT: In this paper, a survey based on experimental data accompanied by a detailed study on the assessment of the carrying capacity of an old Bailey-type steel truss road-bridge that is still in service is presented. This task is achieved through field measurements under static and dynamic loads as well as experimental results based on the properties of the steel material. An analytical model has been employed to assess the carrying capacity of the bridge under seismic loads and wind loads according to the provisions of current regulations. Based on the experimental and analytical results presented herein, strengthening and maintenance measures have been proposed in order to ensure strength and carrying capacity of the bridge under the current requirements. Also, an estimation of the remaining life of the bridge against fatigue is presented taking into account the proposed strengthening measures.

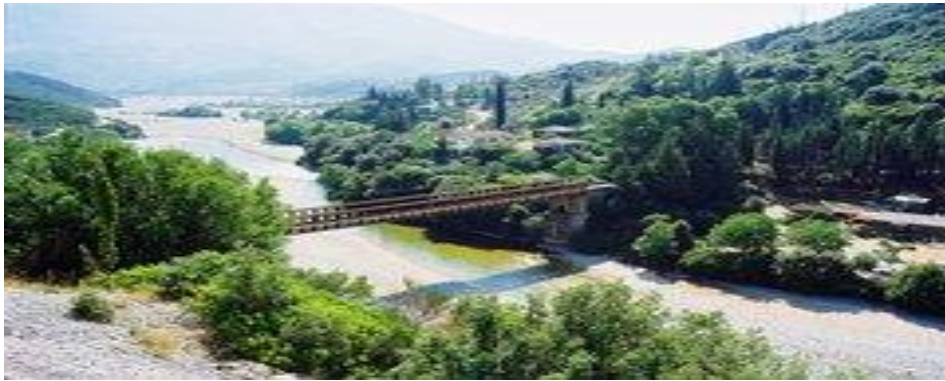
Photo 1. The Bania bridge up to 1986

During the 70's, the increase of traffic loads in the Western sector of National Road Network and the periodical redirection of traffic circulation on the particular road axis (Antirion – Bania bridge – Agrinion – Epirus) in order to cover transport and travel needs has led the local authorities to build an intermediate pier-support in order to strengthen the structure.

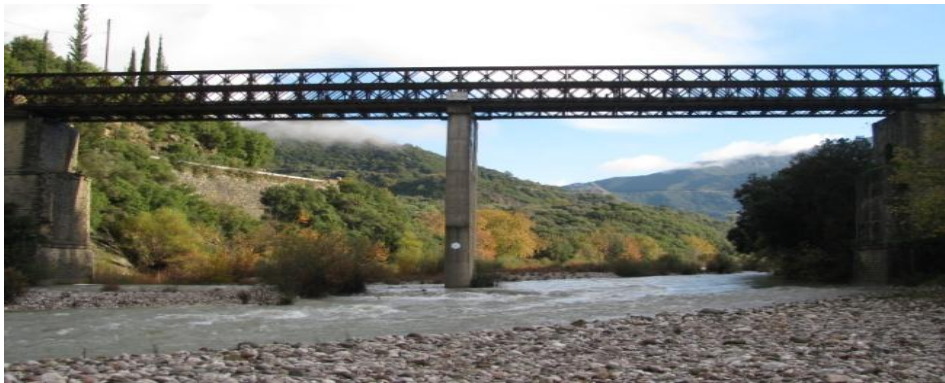
Photo 2. The Bania bridge in its present form

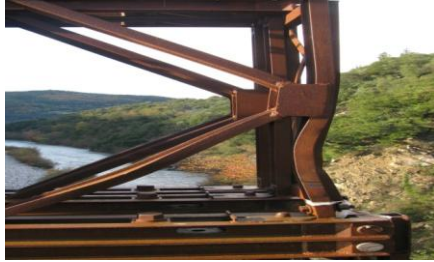
Photo 3. Corrosion of steel

The steel used in this bridge has presented deterioration and damage in various members as well as extensive corrosion.

A full row of bolts is missing at the connection of to the first line of frames. The cross-girders fasteners are relaxed because of cyclic loading. Oxidation of the bridge structure is extensive and deep in all structural elements. During the effort of surface scratching with a metal brush it was not possible to detect clean steel. Because the big height of the frame and the connection detail between secondary beams and the deck, the vertical stiffeners have not been inspected in detail but only visually with the aid of photographs. Also, the intermediate support bearings do not fully conform to the instructions of the manufacturer handbook [3] since the item required to achieve pinned support conditions is missing. All the above findings render enough difficulty to create a reliable model.

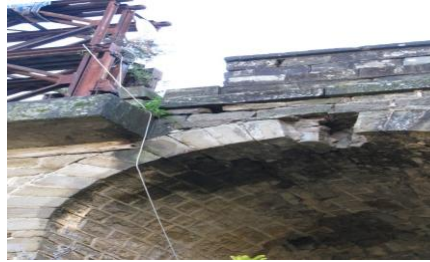
Photo 4. Keystone damage

However, the ideal conditions described in the finite element model and the current regulation are not possible to take into account all the imperfections and structural damages that may influence the operation of the bridge structure. This requires also experimental verification for numerous cases checked against normal use. Evaluating the full structure including the foundation and abutments as well as the superstructure, damages were detected at the bearing positions of the bridge since it rests on stone abutments where a concrete plate has been placed to facilitate the support of the bridge. In both abutments, damage has been detected in the keystone of the arches most likely due to heavy vehicles, which when entering and leaving the bridge cause impact phenomena. During the inspection, it was detected that a small number of frames has suffered damages due to the collision of vehicles on the vertical stands as well as buckling.

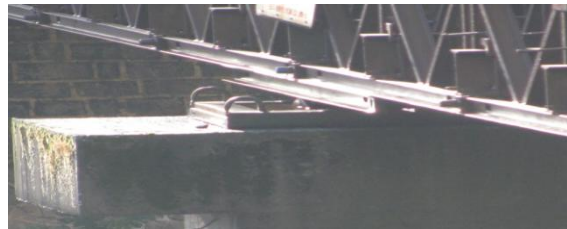
Photo 5. Intermediate support detail

On site measurements of the maximum deflection due to bending with the use of geodetic instruments resulted 34mm. This means that, after erection of the intermediate support, the bridge has been elevated and then was left to rest on the bearing, so that the initial deflection was decreased by 98mm. Taking into account the effect of initial slippage e_o .
