## **INSPECTION AND MAINTENANCE DESIGN OF STEEL BRIDGE**

Raghabendra Yadav

**ABSTRACT:** Bridges are the major elements of road network which should always be in good working condition. Good working conditions can be achieved by routine, periodic and emergency maintenance after the bridge construction. For this study Bokse River Bridge is selected which is located in Jalbire village development committee of Sindhupalchok district along the Balephi (Arniko Highway-Asian Highway) to Jalbire in Nepal. For the inspection and maintenance of bridge the work is divided into two major parts namely desk study and field work. The relevant data related to the bridge was collected during desk study then in the field study the detail survey was done. IRC: SP: 74-2007, Guidelines for Repair and Rehabilitation of Steel Bridges was used for the maintenance of the bridge. Based on the inspection of the structural elements of the Bokse River Bridge, the bridge is in poor condition and needs attention as soon as possible. In this paper, inspection of bridge, geological condition, maintenance design and preventive measures are discussed in detail.

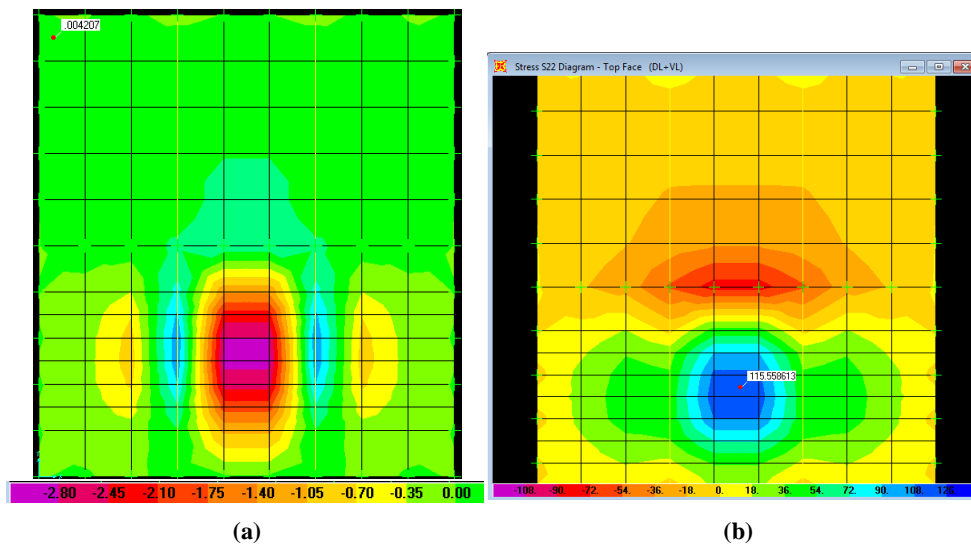
Figure 6. (a) Moment contour, (b) Stress Contour

The spacing of cross girder are at every 900 mm and the stringer are also at a spacing of 900 mm. Again ISA 65x65x6 was used on the bottom of the chequered plate to at the rate of 300 mm to subdivide the plate area to make it stiff. The wheel of IRC A class load was placed between this section so as to achieve critical bending moment and shear. For the finite element analysis of this bridge SAP 2000 was used.

From the finite element analysis it showed that the demand of the load is 2.93 KNm and the capacity of the plate was 10.8 KNm in bending and for the shear the demand was 119.09 N/mm<sup>2</sup> and the capacity was 150 N/mm<sup>2</sup> as shown in Figure 6.

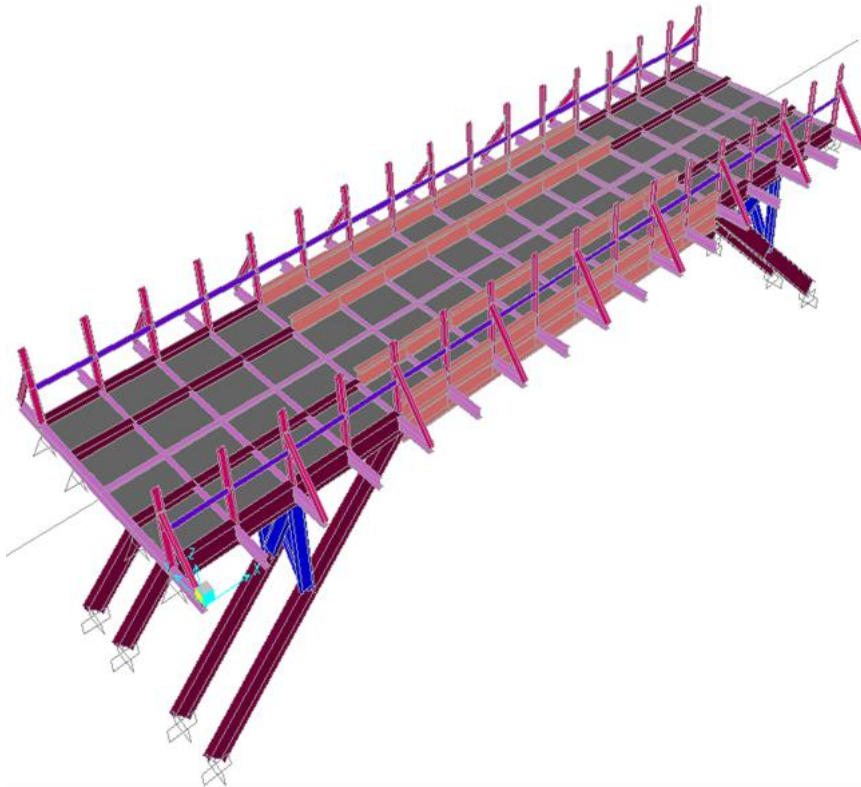
Figure 7. Detailed 3 D model of bridge for analysis

A 3D model was built in SAP 2000 for detailed finite element analysis of the Bokse River Bridge as shown in Figure 7.

For the main girders ISMB 300 was used whose sectional capacity was  $57357.30 \text{ mm}^3$  and the demand was  $29926.67 \text{ mm}^3$  in flexure and  $53.333 \text{ N/mm}^2$  was the stress demand and  $85 \text{ N/mm}^2$  was the capacity in shear. For the deflection, maximum deflection was  $2.35 \text{ mm}$  and the allowable deflection was  $4.50 \text{ mm}$ . Hence from the analysis we can say that the main girder was safe.

For the approach slab, it has to be reconstructed. For the other parts of bridge, rusting should be removed by using sand ballasting methods. Vegetation should be removed.
