## **CASE STUDY: INVESTIGATING THE FAILURE OF KHANI POST-TENSIONED CONCRETE BOX GIRDER BRIDGE IN ZAKHO – IRAQI KURDISTAN**

**ABSTRACT:** Khani bridge in Zakho / Iraqi Kurdistan is under construction on Khabour River. The bridge has one simply-supported span of 63m and designed to have a non-prismatic post-tensioned concrete single-cell box girder section. This bridge, which consists of two box girders (Girder 1 for left side and Girder 2 for right side) encountered an excessive deflection during construction after removing the shores and caused a uniform deflection along the span with a maximum deflection of more than 47cm in the middle for Girder 1 bridge and 67 cm for Girder 2.

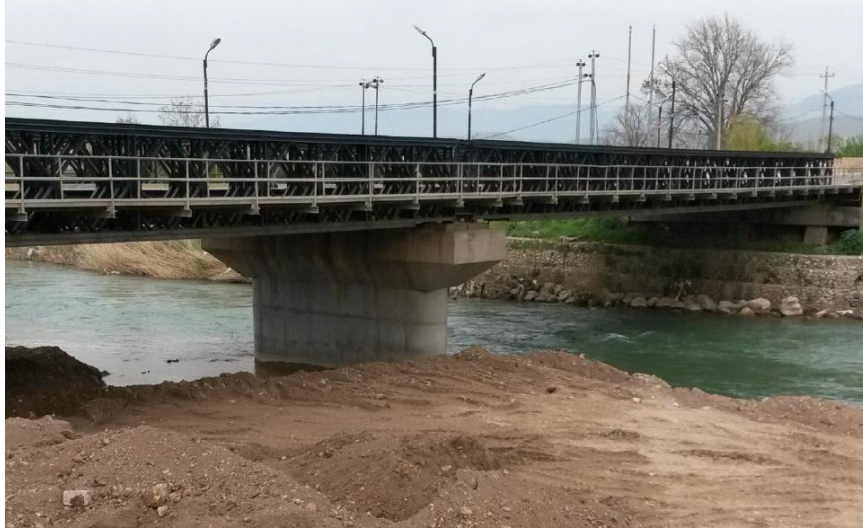
Figure 5. Old Khani Bridge

The new Khani Bridge that is a post-tensioned concrete box girder system was planned to replace the old steel truss bridge shown in Figure 5. The old bridge was two spans that were supported on concrete abutments on the ends and a hammerhead wall pier at the center.

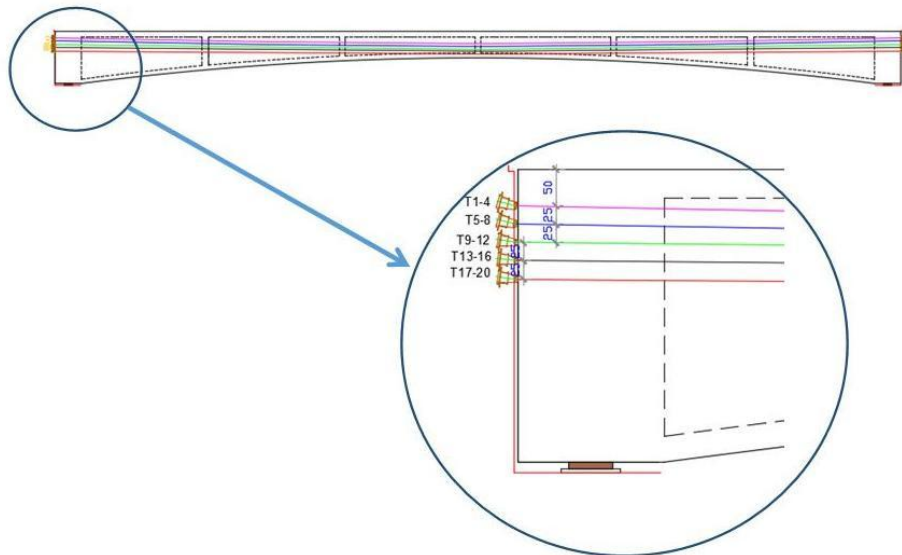
Figure 13. Tendon profile of the original 2012 design

The first thing caught attention was the design of the bridge. People asked whether the design was done by an experienced engineer in designing PTC box girder bridges. The first revision of the design drawings were issued for construction and submitted in May 2012 shows that the tendon profile was designed to have a concaved up shape (smily face) (Figure 13). In 2014, during the construction of the bridge and prior to tendon installations, another revision of the drawings was submitted.

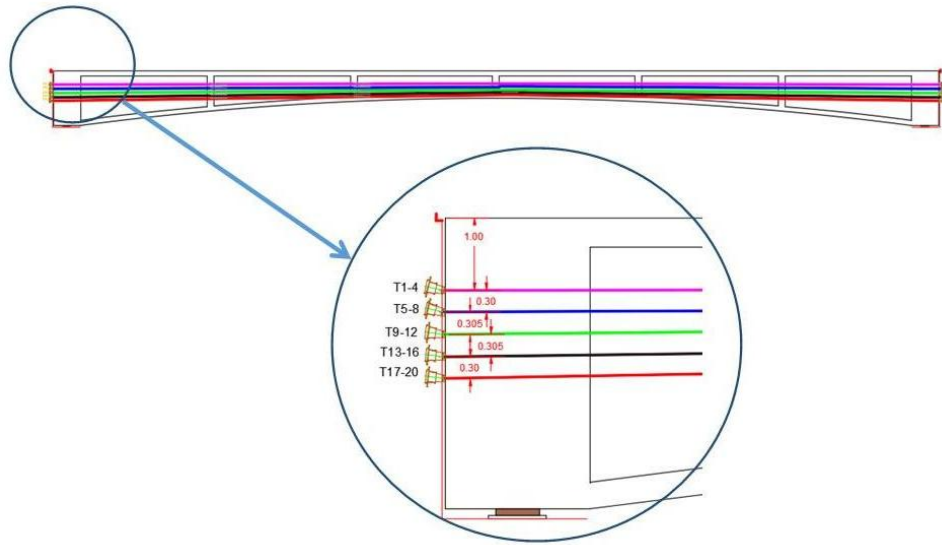
Figure 14. Revised 2014 tendon profile shape

The most significant change in this revision was that of the tendon profile by lowering the centroid of the tendon group at the ends to match the box section centroid and eliminating the eccentricity at the girder ends with an intention to distribute the stress at the ends and reduce the applied moment (Figure 13). This change of the tendon profile was done together with adding two strands per each tendon during a revision process to improve the design. These changes raised skepticism immediately after the bridge failure.

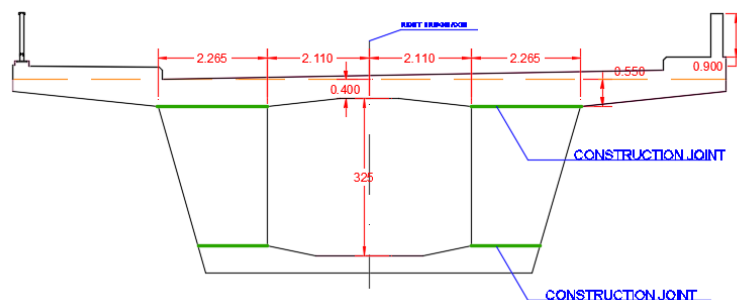
Figure 17. Construction joints in the bridge body

The same report claimed that the cracks at the interface between the top deck and the walls reduced the section and as a result, leads to the excessive deflection. This claim does not have a strong ground because these cracks that mentioned in Mega report did not appear until the deflection reached 180mm according to the site engineers. In fact, the authors of this paper visited the site on the first week that the failure happened and took pictures of the same areas that showing no cracks. The construction joints shown in Figure 17 are those that submitted as part of the design drawings.

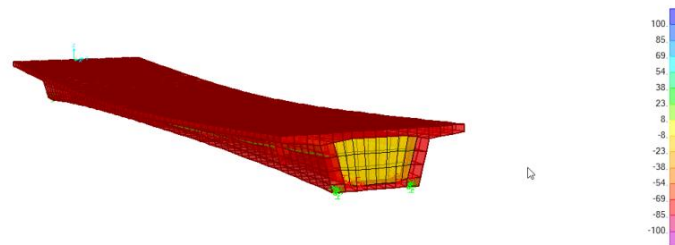
Figure 20. Deflection due to self-weight

1. Deflection induced by the bridge self-weight was 25.6 cm as shown in Figure 20.

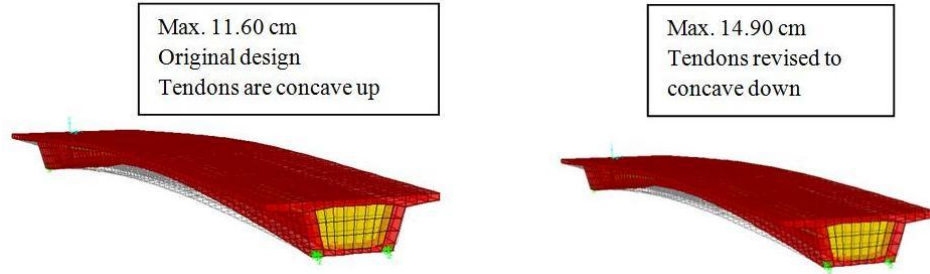
Figure 21. Deflection due to prestress load for the original 2012 design (left) and the revised design (right)

2. Deflection induced by the tendon cable forces was 11.60 cm camber for the original 2012 design and 14.90 cm as camber for the revised design of 2014 (see Figure 21).

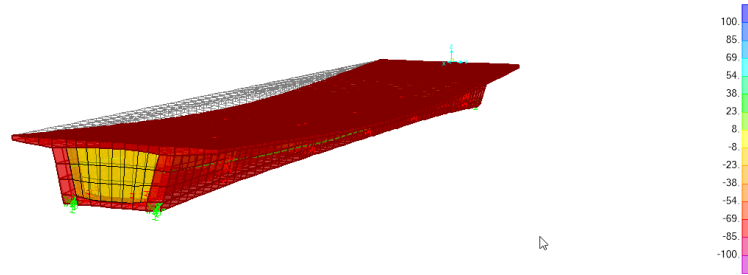
Figure 22. Deflection due to SID

3. Deflection induced by the asphalt and other Superimposed DL was 0.70 cm (see Figure 22).

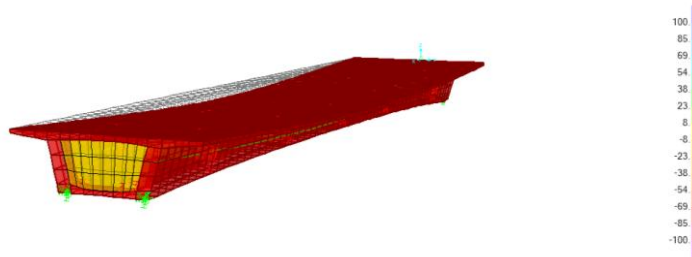
Figure 23. Deflection due to HL-93K LL

4. Deflection induced by the vehicle live load was 1.39 cm (see Figure 23).

The maximum total deflection of the bridge girder at the midspan was 16.09 cm prior to the design revision and after the revision this deflection was reduced to 12.79 cm. This is a first indication that the design was improved by revising the tendon profile. On the other hand, if these numbers are compared to the actual deflection of 47 cm of the Girder 1 and 67 cm of Girder 2, it will be clear that this bridge was not failed because of a design error but rather because of a

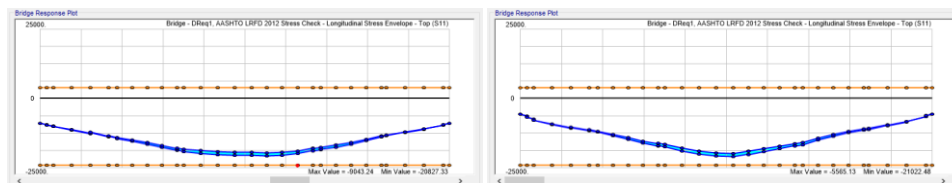
Figure 24. Top fiber compressive stress of Service I load combination of the original design 2012 (left) and the revised design of 2014 (right)

1. Compressive stress from all the loads at top fiber at service was 20.83 MPa for the original design of 2012 versus 21.02 MPa for the revised design of 2014. Both of the compressive stresses are within the allowable pressure of AASHTO LRFD 2012 Compression Limit Stress, which is 24 MPa.

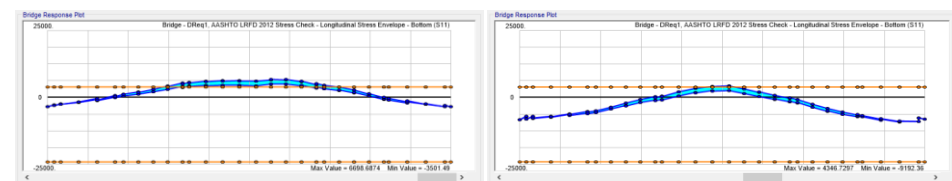
Figure 25. Bottom fiber tensile stress of Service III load combination of the original design 2012 (left) and the revised design of 2014 (right)

2. Tensile pressure at the bottom fiber is checked at Service III for all the loads and resulted in 6.70 MPa for the original 2012 design and 4.35 MPa for the revised 2014 design. Both of these stresses violate the AASHTO allowable limit of 3.984 MPa. However, the violation is rather small and if both of the graphs of Figure 25 were compared, it will be clear that the violation zone is much wider in the original design. By engineering judgement, both of these designs are acceptable for this limit state since the violation is rather small.

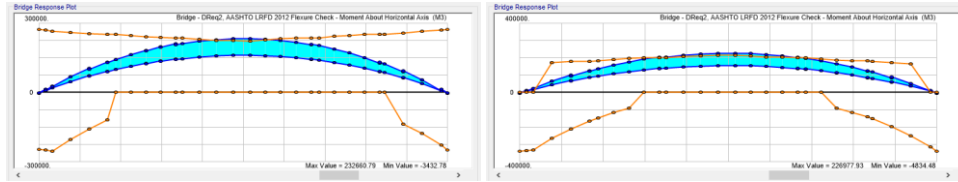
Figure 26. Flexure moment diagram due to Strength I load combination for the original design of 2012 (left) and the revised design of 2014 (right)

3. Applied bending moment according to Strength I load combination is 226,978 kN-m for the original design of 2012 and 232661 kN-m for the revised design of 2014. In both of the scenarios, the flexure moment violates the Resistance Moment at midspan according to AASHTO LRFD, which is 222902 kN-m (see Figure 26). Again, the violation is very slight and therefore, it's acceptable.

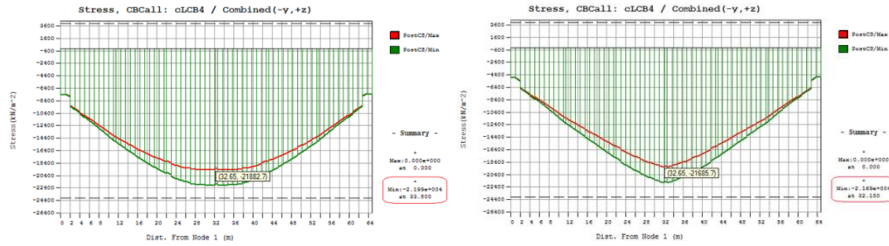
Figure 31. Top fiber compressive stress due to Service I load combination of original 2012 design (left) and revised 2014 (right)

Figure 31 shows that the maximum top fiber compressive stress due to Service I load combination is 22.99 MPa for the original 2012 design and 21.69 MPa for the revised 2014 design. Both of the values are within the allowable as indicated by the dashed line.

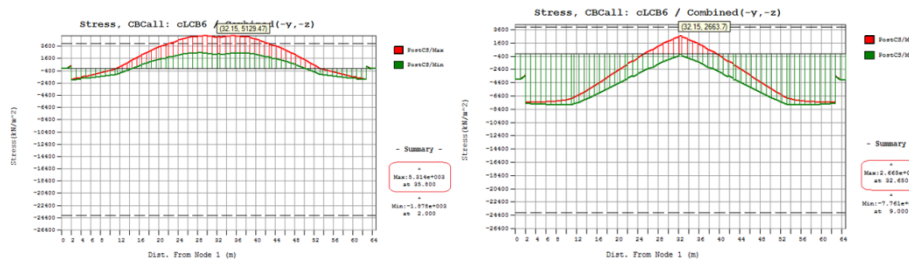
Figure 32. Bottom fiber tensile stress due to Service III load combination of original 2012 design (left) and revised 2014 (right)

Figure 32 shows that the maximum bottom fiber tensile stress due to Service III load combination is 5.21 MPa for the original 2012 design and 2.67 MPa for the revised 2014 design. It can be noticed that this tensile stress crosses the limit specified by AASHTO LRFD and shown as a dashed line in the original 2012 design; while it stays within the limit for the revised 2014 design. This is another indication that the design was improved by the revision of 2014.
